INVESTIGATION OF HYDROTEST FAILURE
OF THIOKOL CHEMICAL CORPORATION
260-INCH-DIAMETER SL-1 MOTOR CASE

by John E. Srawley and Jack B. Esgar

Lewis Research Center

Start
The Thiokol Chemical Corporation 260-inch-diameter SL-1 ^A motor case failed during hydrotest at a pressure of 542 pounds per square inch, which was about 56 percent of proof pressure. The motor case was constructed of 250 grade ^{FEB} maraging steel plate joined mostly by submerged arc automatic welding. An investigation of the failure was conducted by a Committee composed of members from Industry and Government. Investigation showed that the failure originated from a defect that was not detected by nondestructive testing techniques prior to aging. Nondestructive testing was not conducted between aging and hydrotest. The defect causing the failure was in the heat-affected zone of a longitudinal submerged arc weld on the cylindrical section of the motor case. The area where the defect was located had been repaired by a manual gas-tungsten-arc (TIG) weld. The defect, which was submerged within the vessel wall and oriented longitudinally, was approximately 1.4 inches long and had a width of about 0.10 inch. Four other

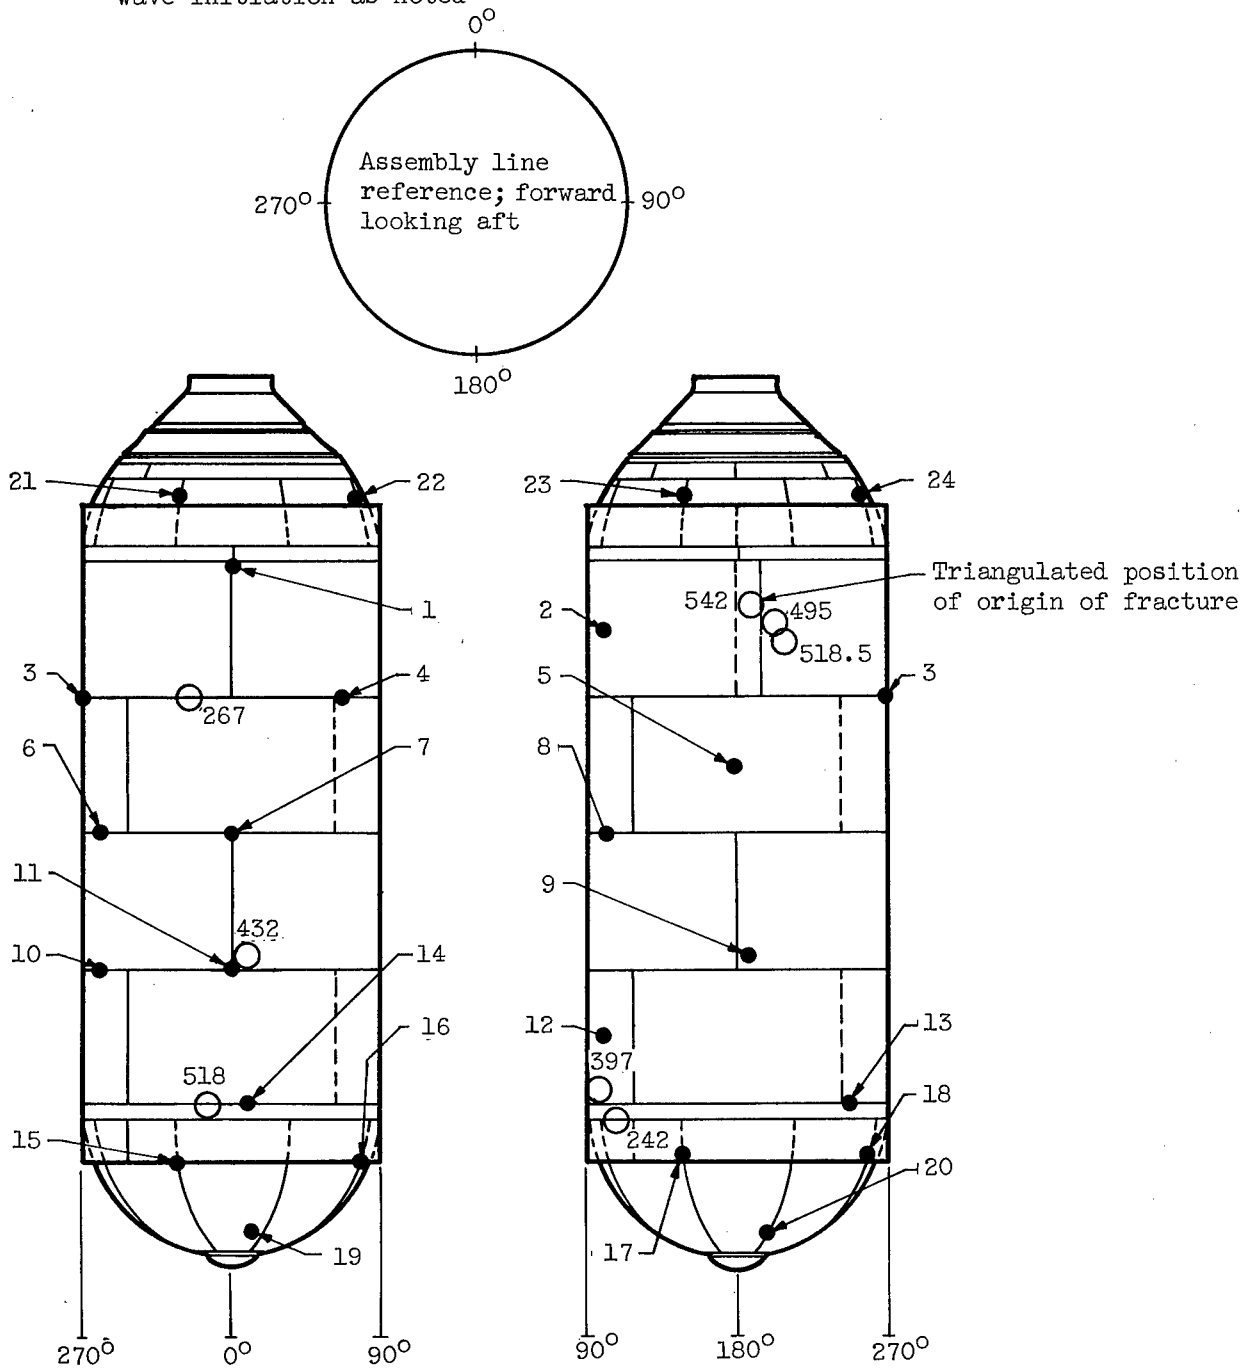
Figure 3. - Locations of accelerometers and stress wave origins on 260-inch-diameter SL-1 motor case.

During hydrotest, the accelerometer system mounted on the motor case indicated eight stress waves, including the wave that occurred at failure. The predicted origins and the pressures at stress wave initiation are also shown in figure 3. The first stress wave occurred at a pressure of 242 psi. Previous experience in using a stress-wave detection system on hydrotest of motor cases has shown similar stress wave initiations in areas not related to final failure. Three of the stress wave origins were in the region of the lower skirt where the motor case was bolted to the hydrotest thrust stand. It is probable that some of these stress waves resulted from movement at the bolt holes.

Independent confirmation of the general location of the fracture origin was obtained by triangulation based on the recorded accelerometer signals. As discussed in appendix B, the origin of the stress wave detected at the time of failure was estimated to be located within a 20-inch-diameter circle centered at a point 8 inches from the W7/302 weld and 29 inches forward of the W8/3 weld. This location, shown as a dashed circle in figure 7(b), is in good agreement with the position of the source of the fracture paths.

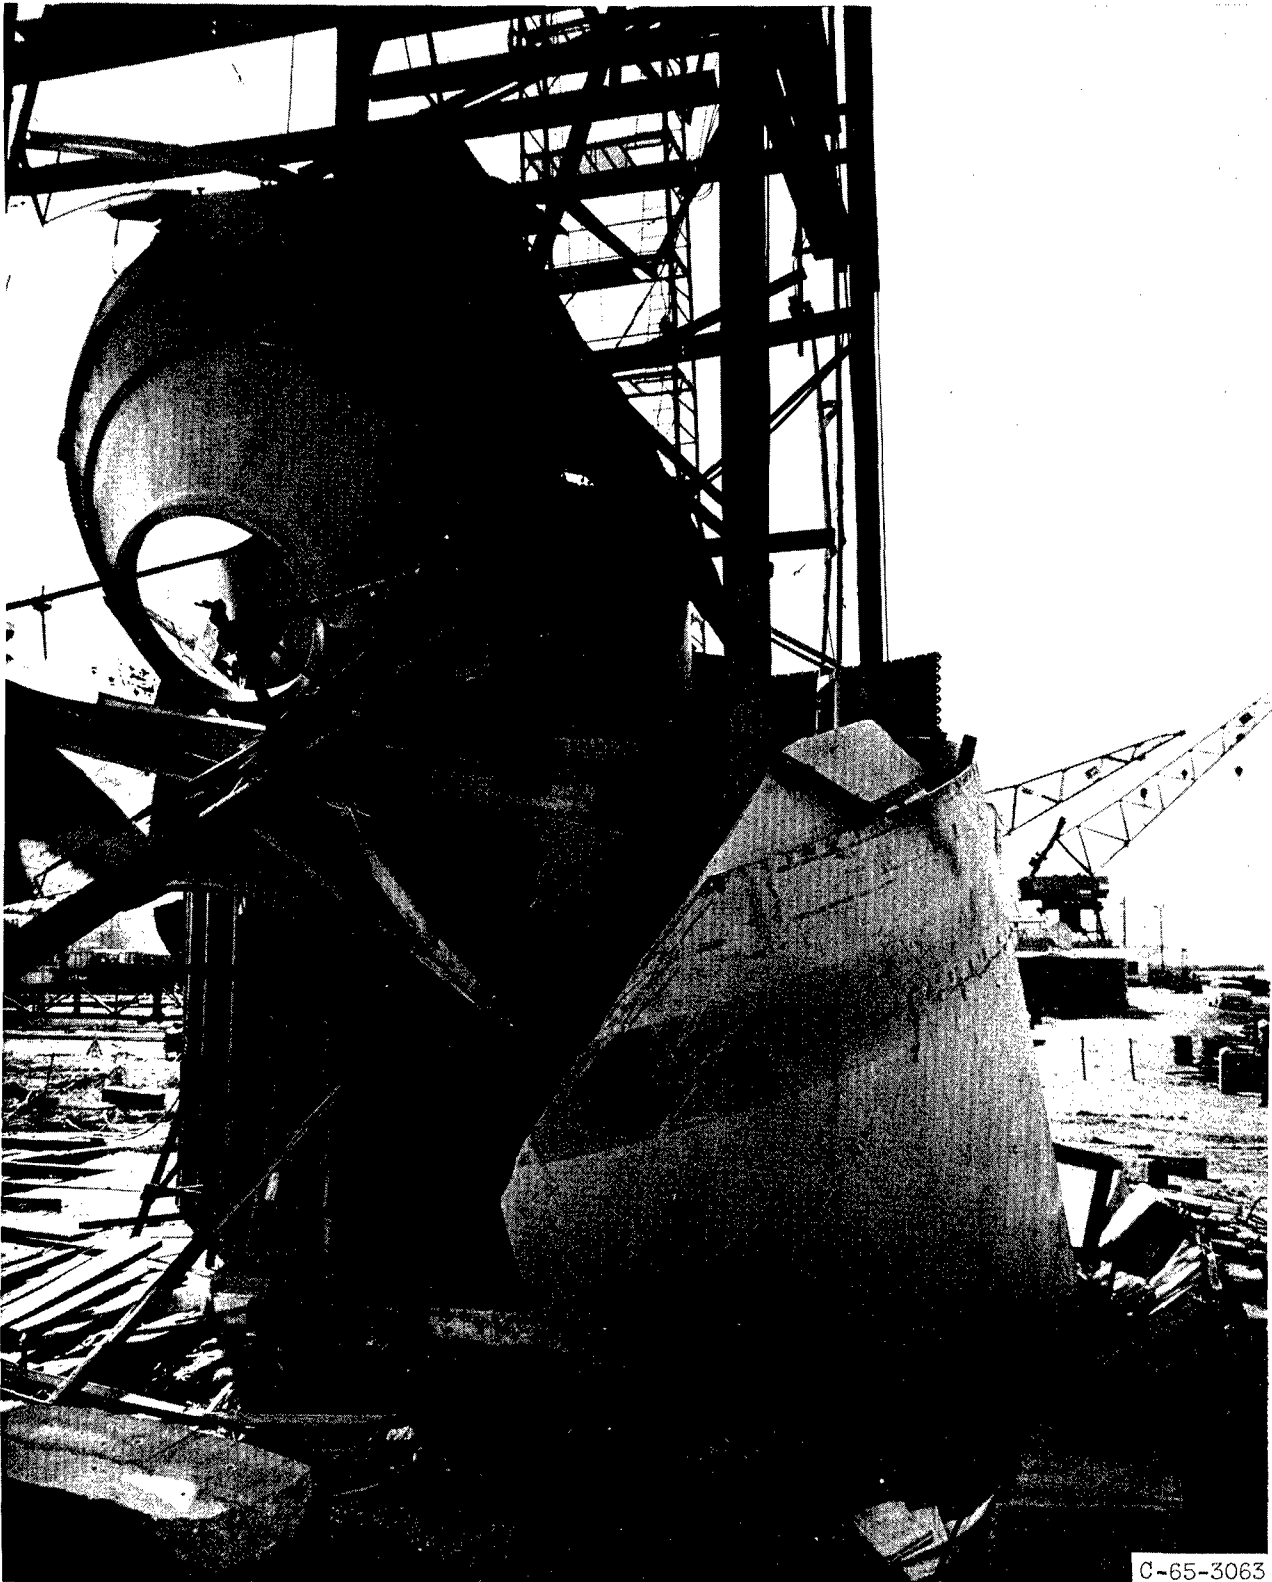
On failure at a gage pressure of 542 psi, the motor case had shattered into several large pieces and many smaller ones that fell into a precarious, interlocked pile within the test tower. Several days were required to remove the pieces to a large shop where they were laid out on the floor for detailed examination. Figure 5 is a photograph taken during this operation that shows the test tower site. A large piece consisting of the aft head and part of the cylindrical section is resting in the framework of the tower, and another large piece of the cylindrical section that had been removed from the tower is shown in the foreground. In spite of the lengthy exposure in the open air, the fracture surfaces were not visibly rusted; nor were they mechanically damaged in handling to any important extent. It was necessary to cut two of the larger pieces with a torch to facilitate removal, but these cuts did not impair the subsequent examination. Figure 6 shows the pieces laid out on the shop floor with the aft head in the center foreground and the other pieces arranged as nearly as possible in proper relation to one another.

Figure 5. - Portion of failed motor case as it was being removed from hydrotest tower.

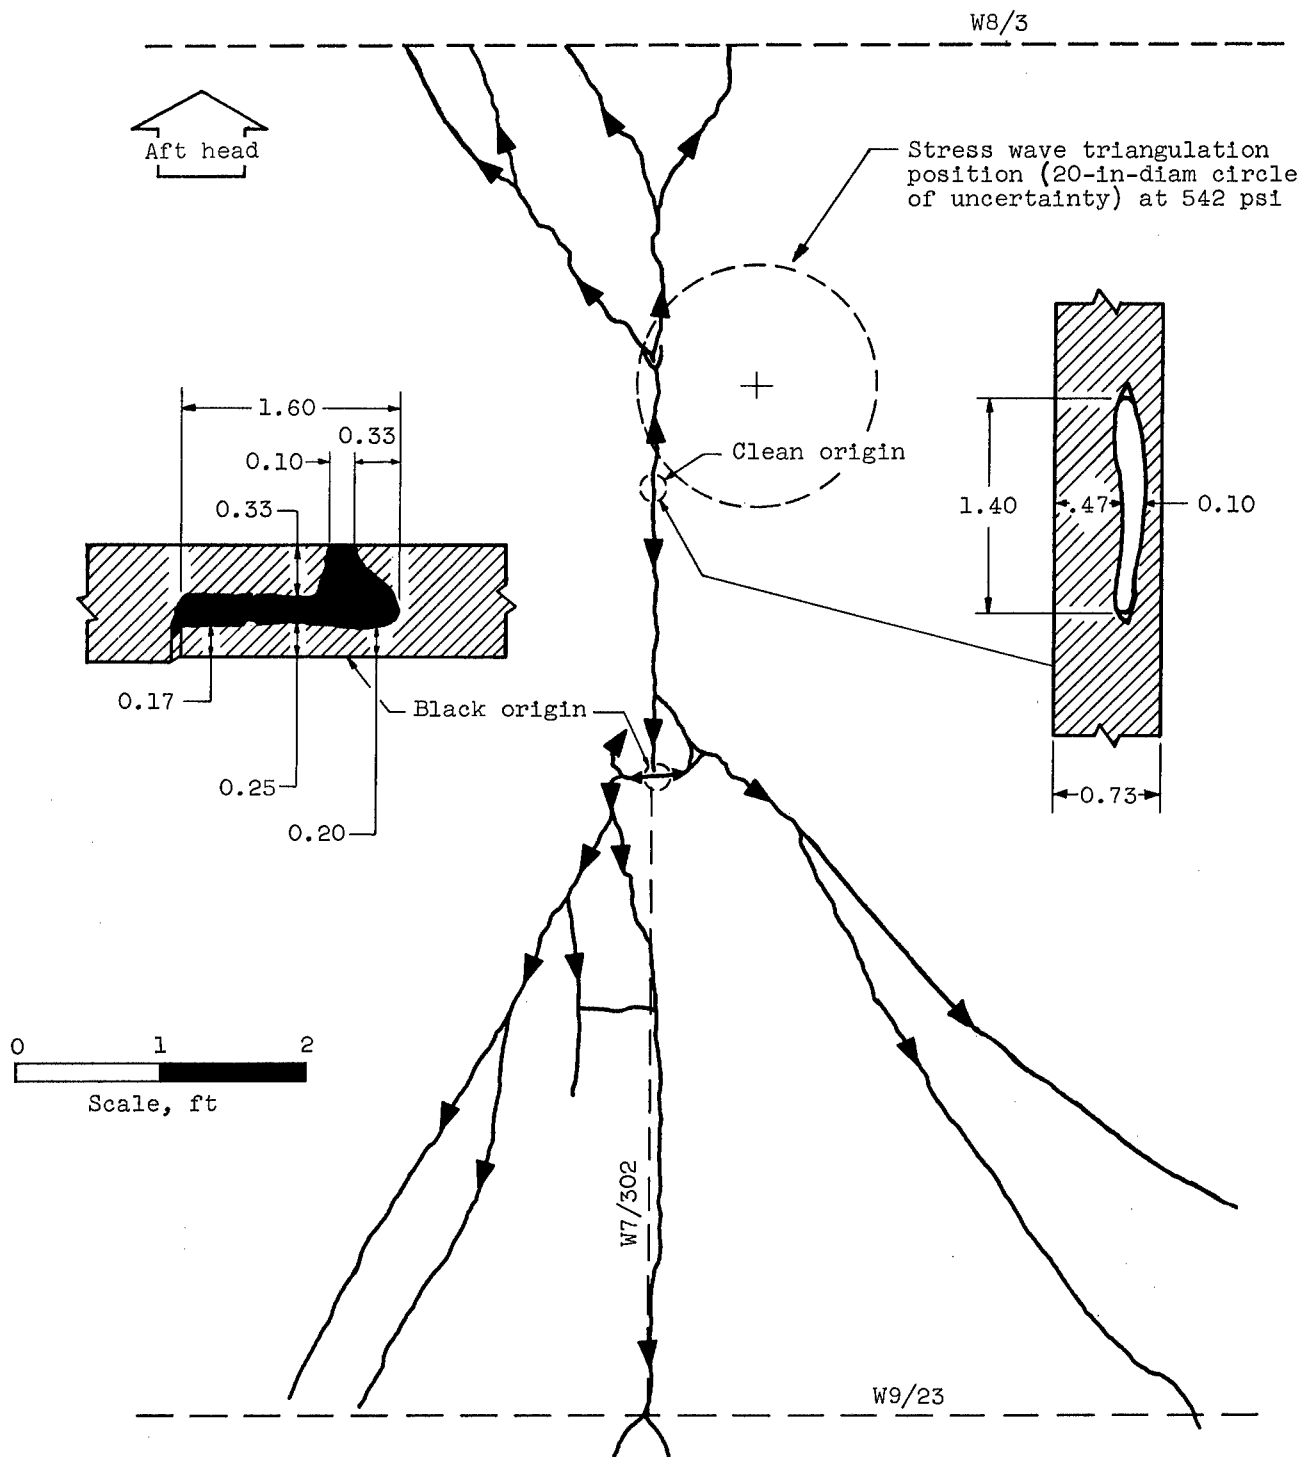
From the fracture map (fig. 7), it is clear that the fracture pattern developed from an origin close to the W7/302 longitudinal weld and somewhat forward of the W8/3 aft Y-ring weld. Although they are not shown here, the fracture paths in the skirts and the domes were completely mapped, and it was established that they had developed from cracks running out of the cylindrical section. There were no independent origins in these parts of the motor case, although there were one or two fracture branches that had run from the cylinder into one of the heads and then continued on back into the cylinder.

In fact, the local fracture pattern in figure 7(b) can only be explained satisfactorily if it is assumed that fracture started first at the clean origin with the initial, longitudinal crack running both aft toward the head and forward toward the position of the black origin. The intensity of the stress field around the black origin would have increased with the approach of the crack, so that secondary crack propagation would have been triggered at the black origin before the primary crack reached it. The subsequent intersection of the developing transverse crack by the primary crack would then have disturbed the stress field in a way that would account for the early branching of both ends of the transverse crack. Since the velocity of propagation of brittle fracture in steel can approach 5000 feet per second, it is likely that the interval between primary and secondary crack initiation would be of the order of a millisecond.

(b) Detail in immediate vicinity of primary and secondary origins. Inset sketches show shapes and dimensions of the two origins.

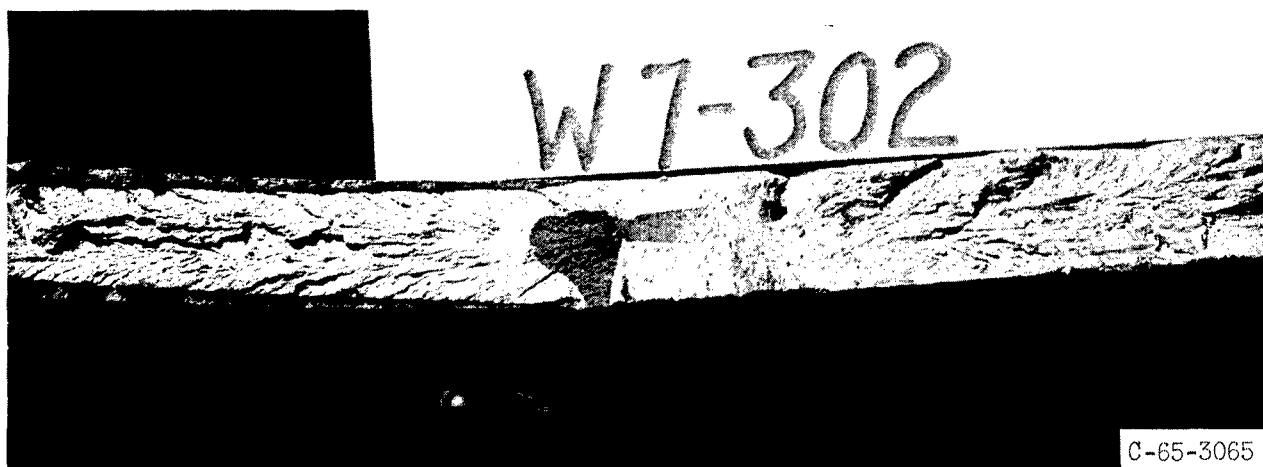
Figure 8. - Typical chevron markings on fracture surface showing directions of fracture propagation away from black origin.

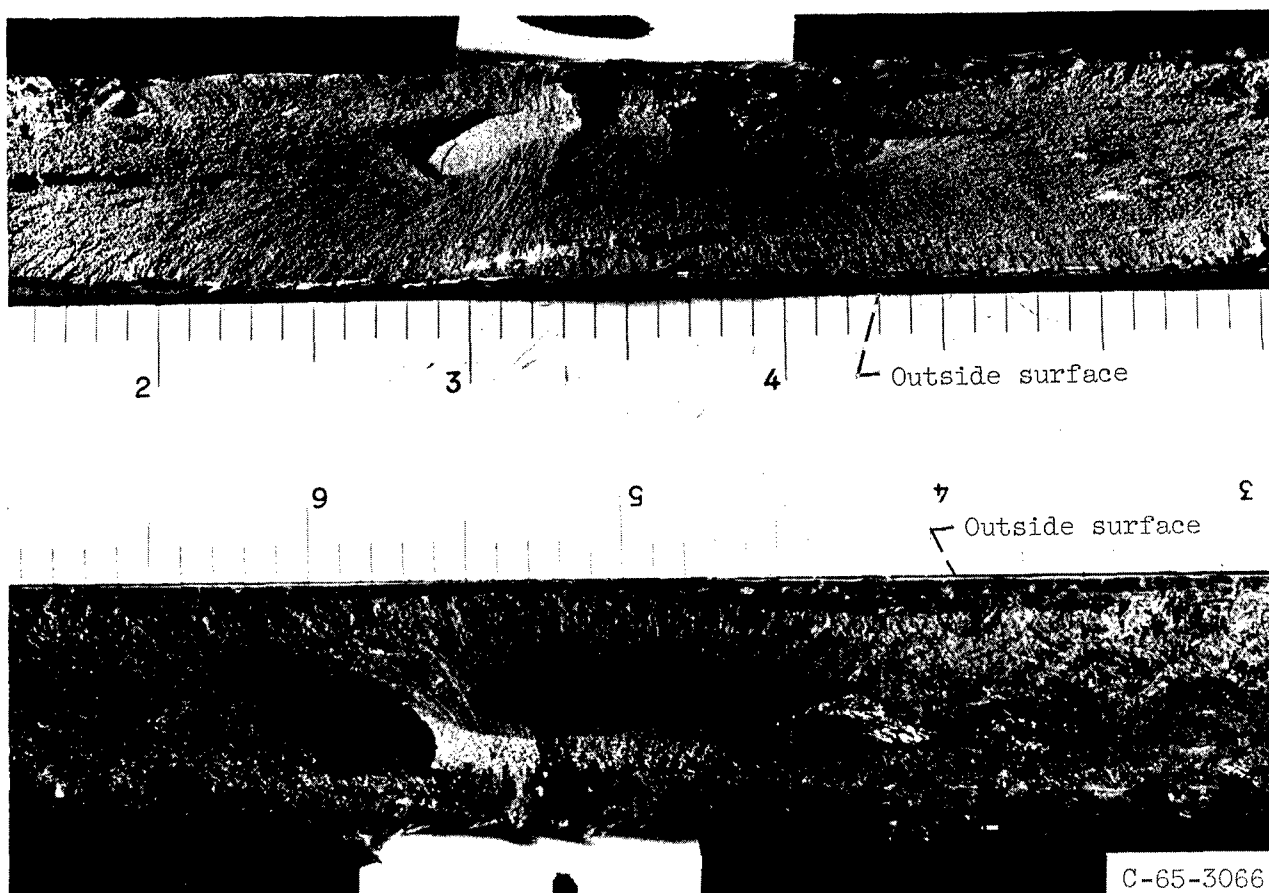
Two distinct fracture origins were discovered in the expected region, both associated with areas of TIG weld repair on the inside surface of the W7/302 weld. One origin was oriented parallel to the weld centerline, and the other transverse to it. The positions of these origins and sketches of their contours are shown in the detail fracture map (fig. 7(b)). Because of the obvious difference in appearance to the naked eye, the longitudinal defect was termed the "clean" origin, and the transverse defect the "black" origin. Photographs of the mating surfaces of the clean origin are shown in figure 9. The boundary is quite distinct except for two damaged places on one of the mating surfaces that must have rubbed against another piece of metal, but the appearance of the origin surface differs only in texture and tone from that of the surrounding fracture: there is no suggestion of a deposit on the surface. On the other hand, the black origin was covered with a tightly adhering, black deposit, as shown in figures 8 and 10. This deposit was eventually identified as essentially an iron oxide. This difference between the two origins is probably connected with the fact that, whereas the boundary of the black origin extends to the outer surface of the vessel wall, the clean origin is completely submerged within the wall.

Figure 9. - Mating surfaces of clean origin on W7/302 weld.

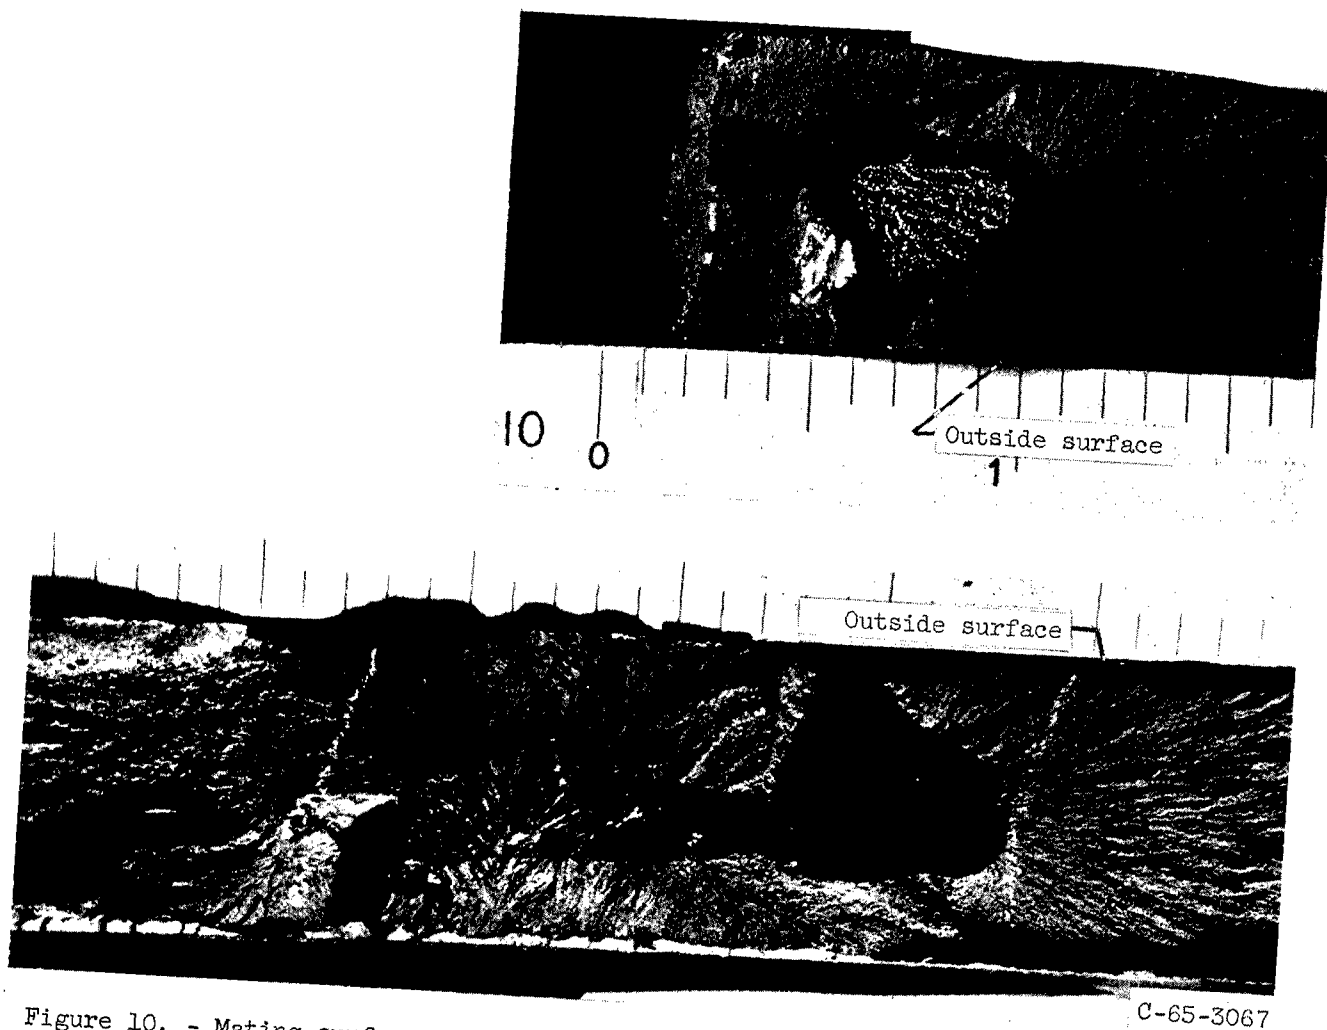
The black deposit on the transverse origin was examined by glancing-angle X-ray diffraction, electron diffraction, and electron-probe microanalysis. The diffraction patterns corresponded to a mixture of ferrous oxide (Fe_2O_3) and ferric oxide (Fe_3O_4). The analysis showed that the metallic constituent was predominantly iron with small amounts of nickel, molybdenum, cobalt, and titanium. This oxide must have formed at a high temperature. Comparison of the color with oxidized crack surfaces obtained by heating in air at high temperatures suggests a formation temperature at least as high as 800° F. It would appear that at least some of the oxidation must have occurred during the aging cycle at 835° F.

Figure 10. - Mating surfaces of black origin on W7/302 weld. (Part of black material has been removed from one surface for analysis.)

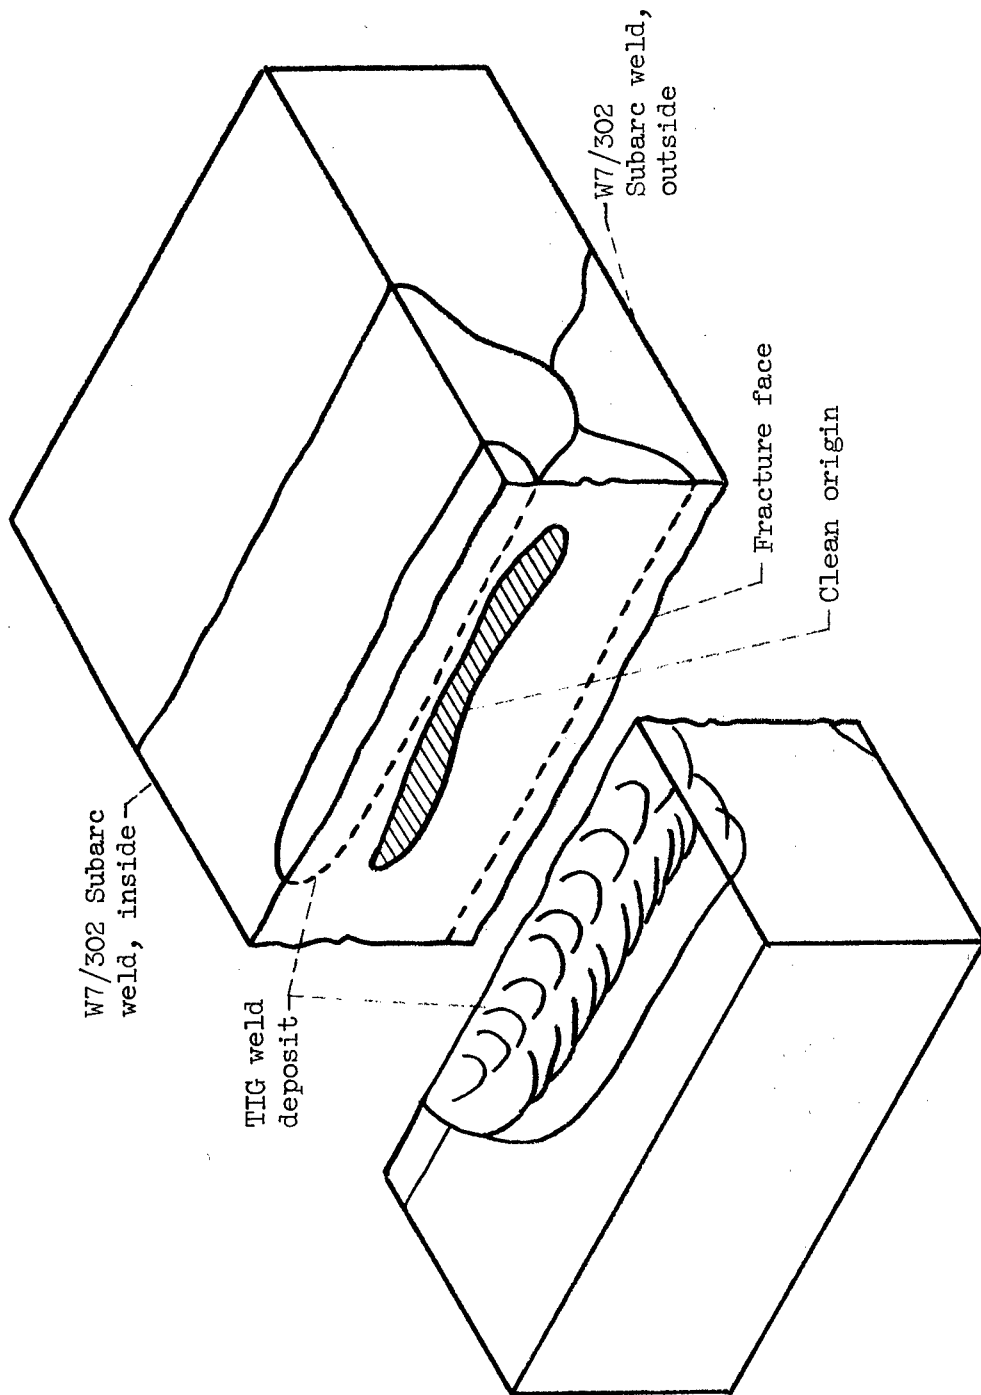
ground and etched to reveal the positions of the fusion lines and heat-affected zones of the W7/302 weld. It was then found that each origin was located beneath a separate manual TIG weld that had been deposited on the inside of the vessel to replace part of the original subarc weld. These locations are indicated in figures 11 and 12. The clean origin (fig. 11) was located near one edge of what appeared to be a fusion line TIG repair weld, and the black origin (fig. 12) was located near one end of a TIG repair, which covered the whole width of the weld and heat-affected zones. These locations are discussed in greater detail later. The TIG weld areas were identified by the responsible welding engineer as simulated repairs to an originally sound subarc weld. The simulated repairs had been made as part of an investigation concerned with cracking that had been encountered in TIG repair welding of meridional dome welds. Experimental TIG repairs had been made at three places on the W7/302 weld, but a total of four nondestructive inspections by PT, UT, and RT at times varying from 1 day to 19 weeks after the repairs were made had revealed no indications of defects in the repaired regions. The more detailed examination of the two origins is discussed in the next section, following discussion of the sequence of fracturing.

Figure 11. - Isometric drawing showing relation of clean origin to weld deposits.

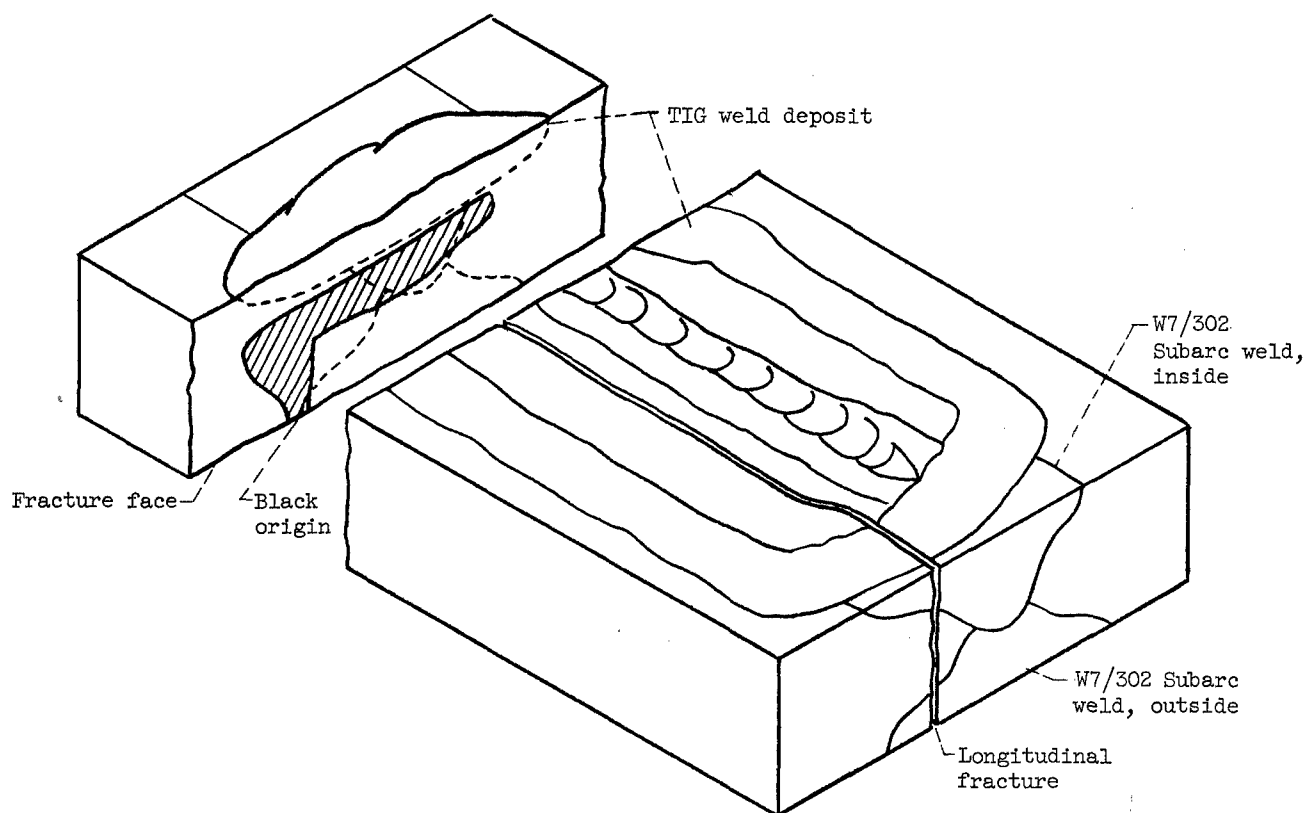
Figure 12. - Isometric drawing showing relation of black origin to weld deposits.

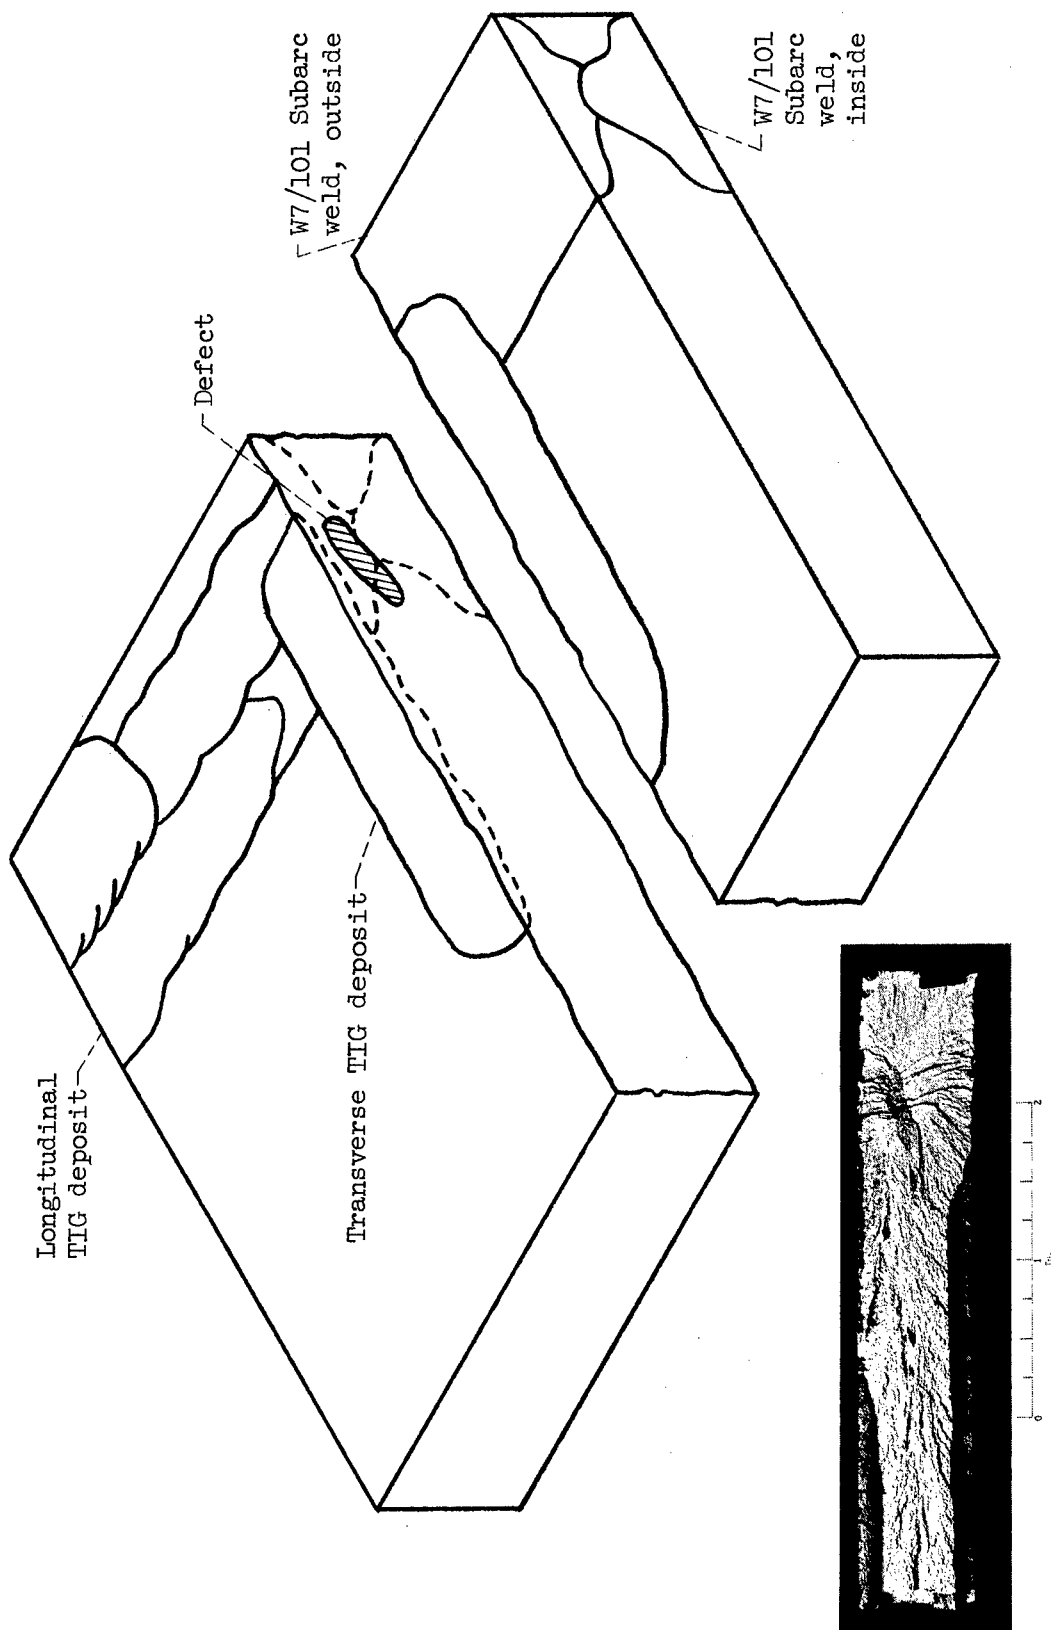
The association of each of the origins with a TIG repair weld, and the nature of the origin surfaces, suggests that their formation was a consequence of TIG repair welding. This suspicion is reinforced by the finding of three other flaws associated with TIG weld repair regions. A tension test specimen taken from the W7/101 weld after hydrotest failure was used to examine one of these flaws shown in figure 13. This flaw and two flaws that were found in the W6/3 TIG weld are discussed further in the section Reinspection of Weld Repair Areas After Hydrotest Failure. The detailed mechanism of formation of the flaws has not been established, but it appears that the defects were generated by stresses set up during TIG repair welding in regions exhibiting microstructural inhomogeneity and grain coarsening.

Figure 13. - Isometric drawing and photograph of fracture surface of longitudinal tension specimen from W7/101 weld region showing defect related to weld deposits.

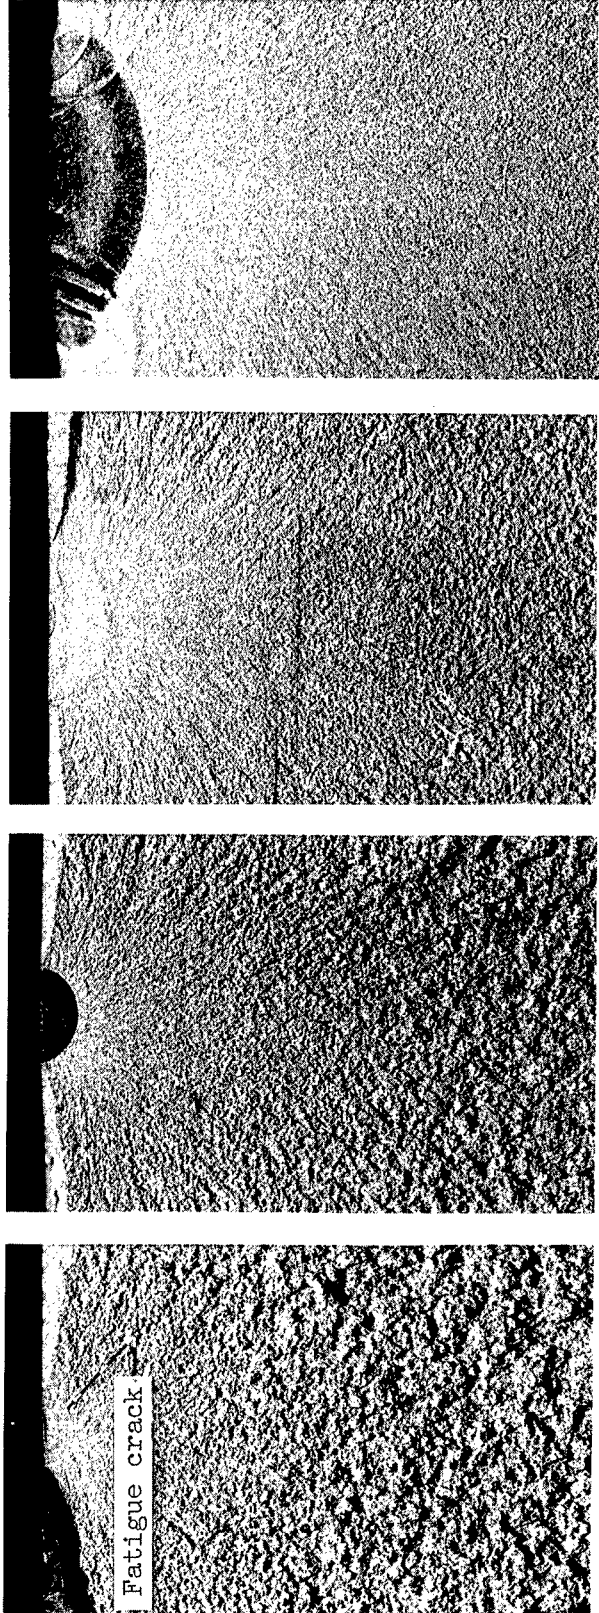
Specimen:	B	C	D	E
Fatigue crack depth, in.:	0.030	0.041	0.063	0.106
Fatigue crack surface length, in.:	0.075	0.100	0.155	0.309
Thickness, in.:	0.743	0.747	0.713	0.737

Figure 18. - Fatigue cracks in test plates for nondestructive inspection evaluation program. X5.
(Specimen A had no fatigue cracks.)

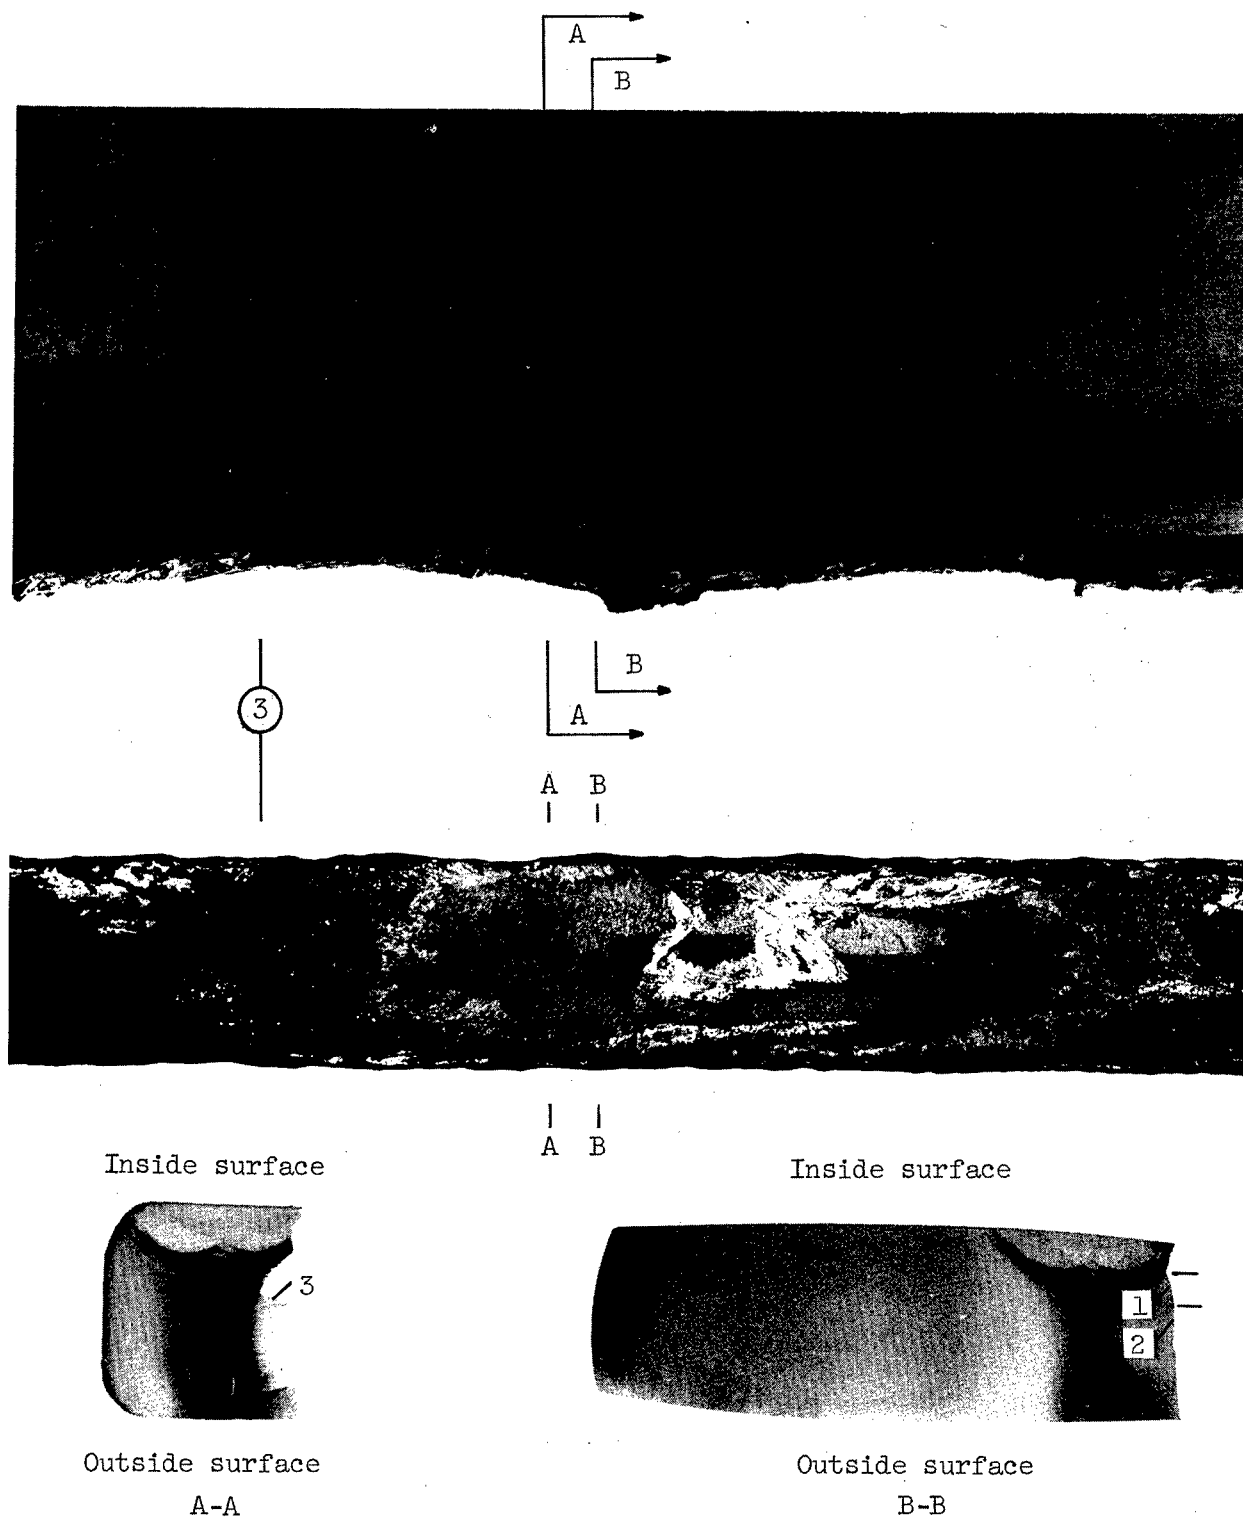
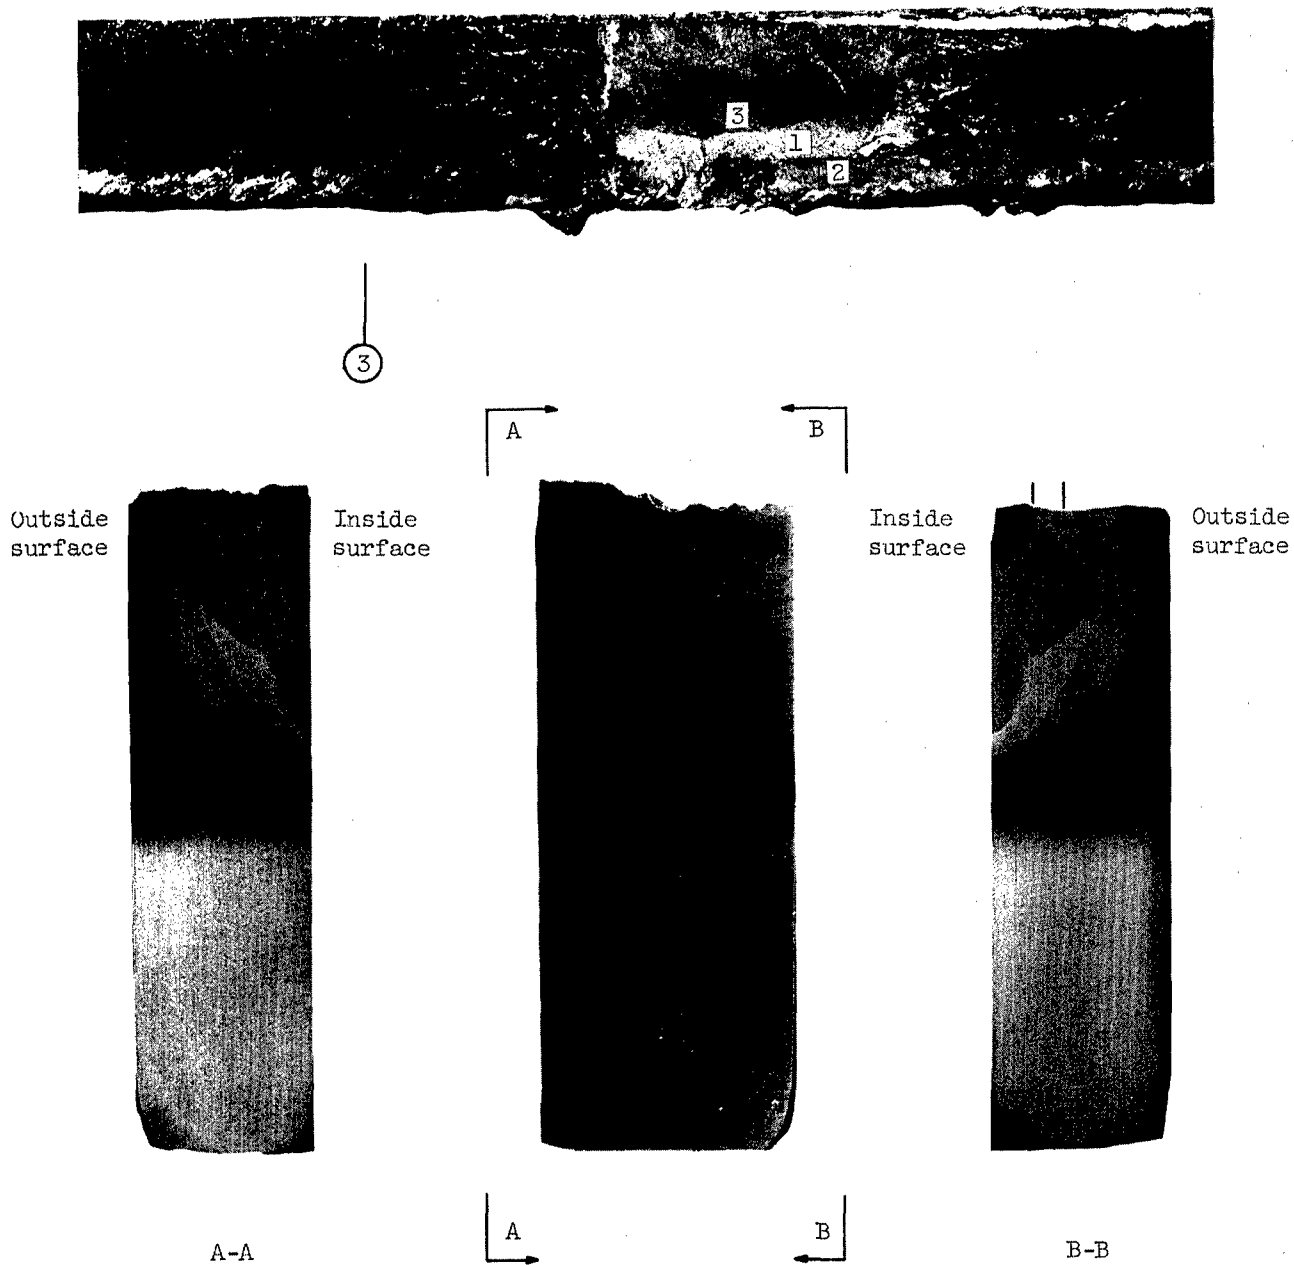
Figure 20. - Photomacrographs of clean defect region. $\times 1.5$.

By optical microscopic examination of fracture profiles in polished sections, and electron microscopic examination of fracture replicas, it was ascertained that the fracture topographies of the two origins were quite similar to one another, but different from adjacent fracture surfaces. The origin surfaces were predominantly intergranular, with relatively flat facets that corresponded either to prior austenitic grain boundaries, or to dendrite interfaces in the case of that part of the black origin located within the weld. The surrounding fracture surfaces were predominantly of the noncrystallographic, dimpled type, which is indicative of more ductile rupturing.

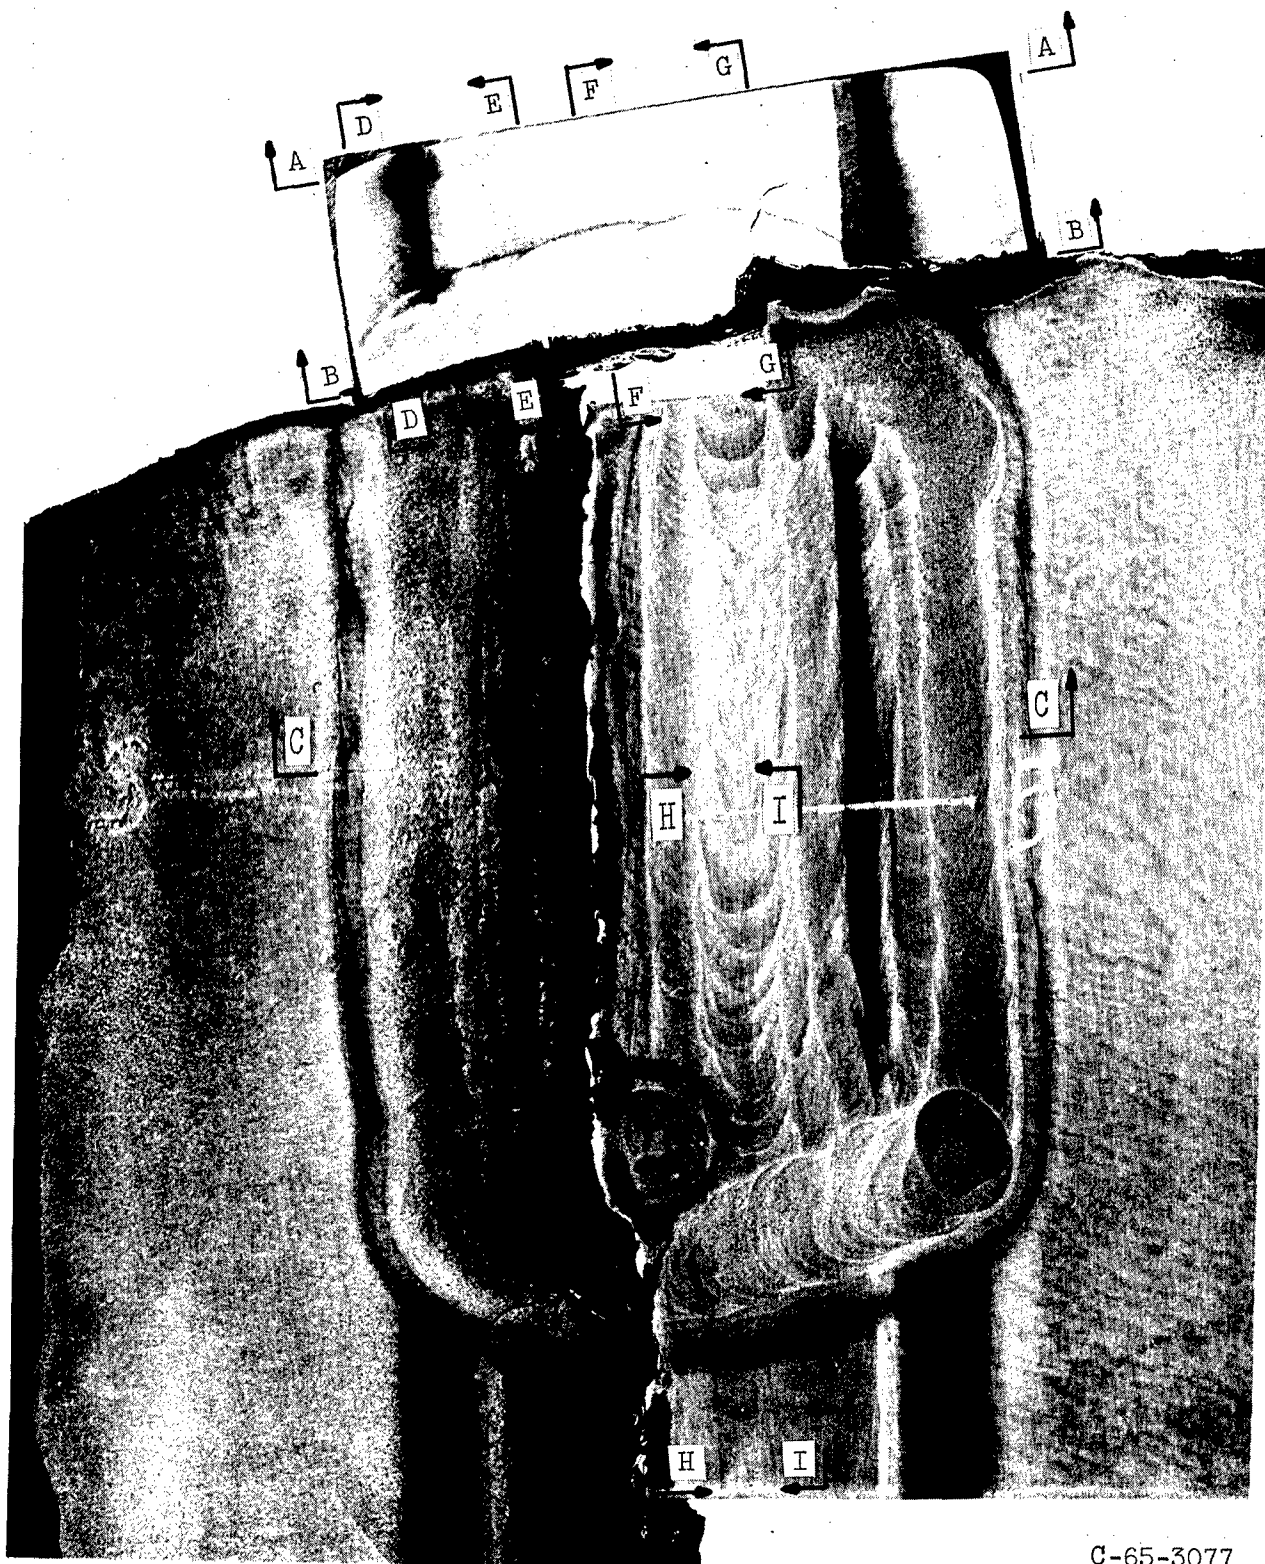
Figure 25. - Composite view of black defect region. Fragments 5, 6, and 8.
x1.5.
